**EFFECTS OF ENVIRONMENT ON CREEP BEHAVIOR OF
NEXTEL720/ALUMINA-MULLITE CERAMIC COMPOSITE
WITH $\pm 45^\circ$ FIBER ORIENTATION AT 1200°C
THESIS**

AFIT/GSS/ENY/09-M05

**DEPARTMENT OF THE AIR FORCE
AIR UNIVERSITY**

Degree of Master of Science (Space Systems)

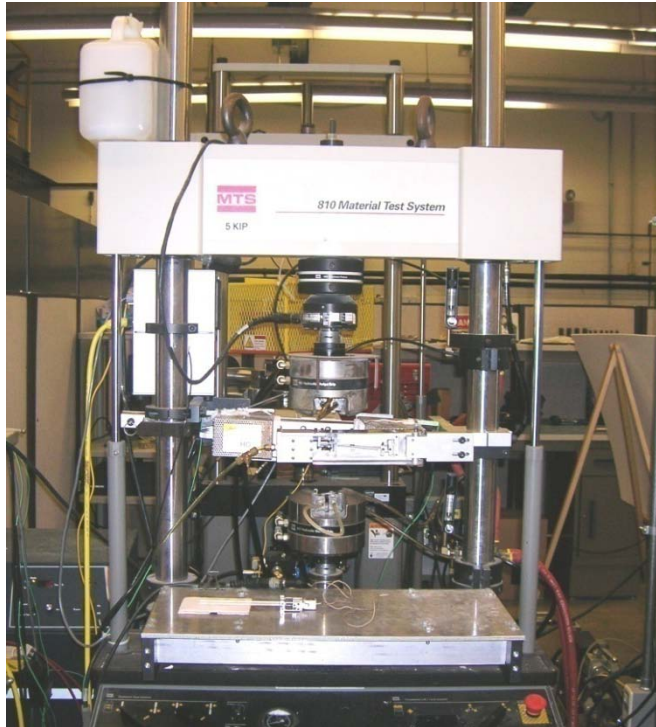
Figure 4. MTS 5 kip mechanical testing machine

An MTS Corporation model 810 servo-hydraulic testing machine with the load capacity of 5.5 kip (25 kN) was used for all mechanical testing for this research. The machine was equipped with MTS 647 hydraulic wedge grips. In order to prevent the slippage of a specimen, each wedge was coated with a layer of surf alloy. The grips were water cooled down to 15°C by a NESLAB model HX-75 chiller. Grip pressure of 8 MPa was used in all tests. The machine was equipped with an MTS Teststar II digital controller to generate input signals and acquire data. The MTS Multipurpose Testware (MPT) software was used for the programming of automated test routines and data collection.

The 5 kip mechanical testing machine and 5 kip mechanical testing station can be seen in Figures 4 and 5, respectively.

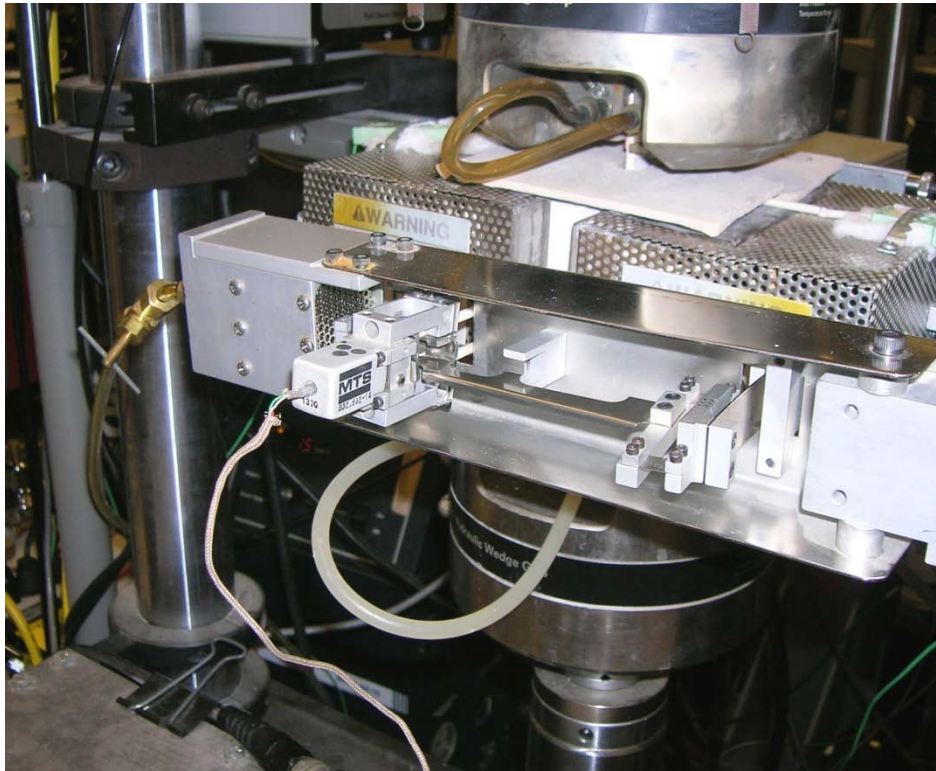
Figure 6. Extensometer platform with heat shield and cooling air

Strain measurements were performed with an MTS high temperature low contact force extensometer with a 12.77 mm gage length. A heat shield and an air cooling system were used to protect the extensometer from the high temperatures required for this research. The extensometer was calibrated to measure tensile strains between -5% to 20% (see Figure 6).

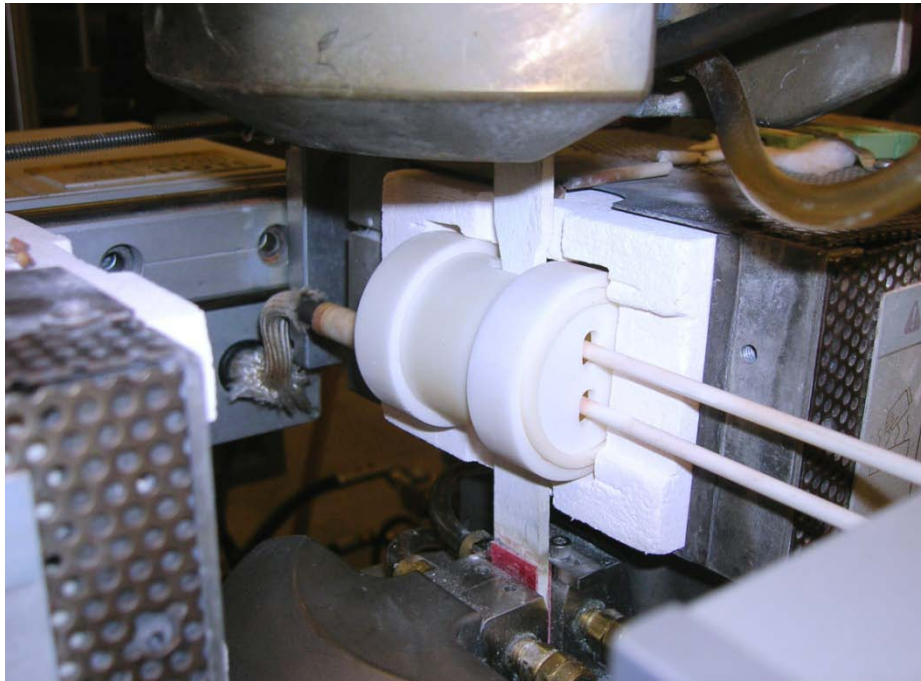
Figure 8. Alumina susceptor and steam feeding tube on the 5 kip machine

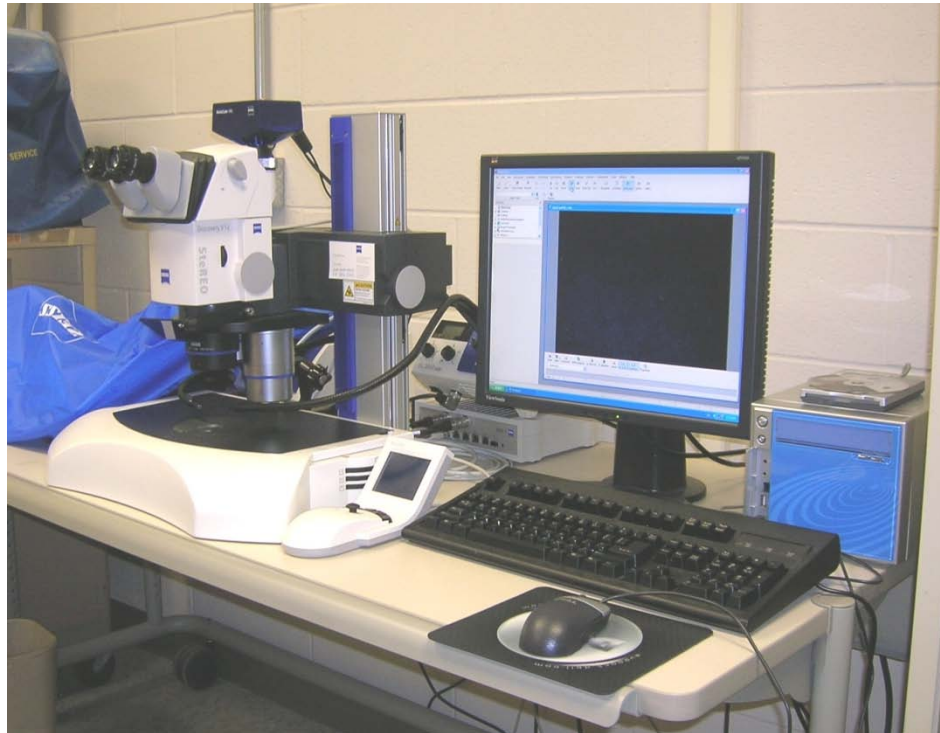
Figure 9. Zeiss Stemi SV II optical microscope

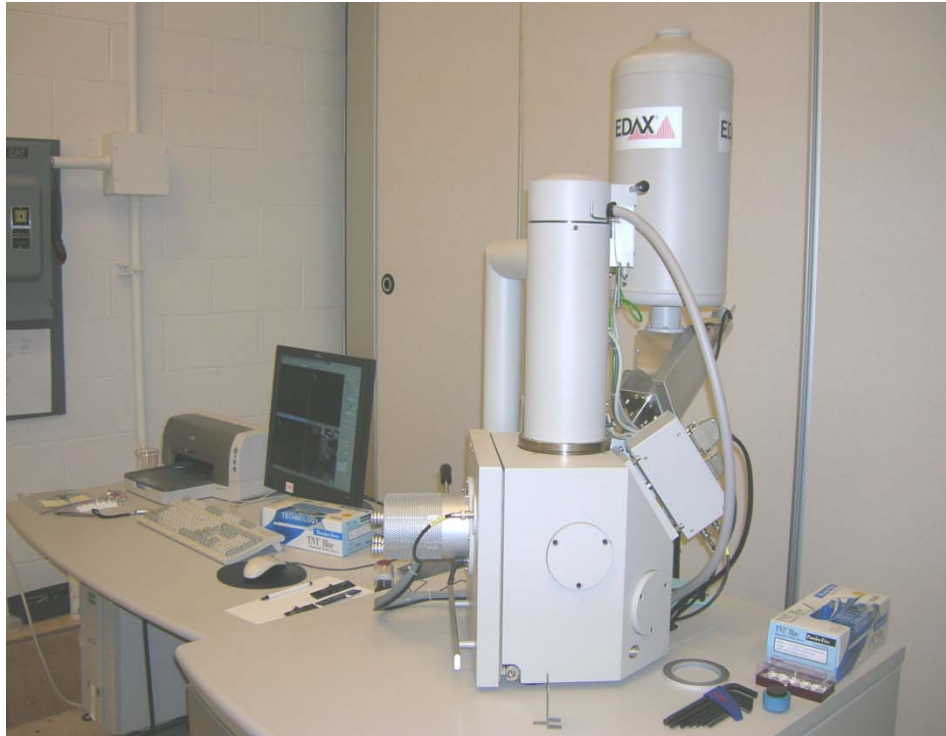
Figure 10. FEI Quanta 200 Scanning Electron Microscope

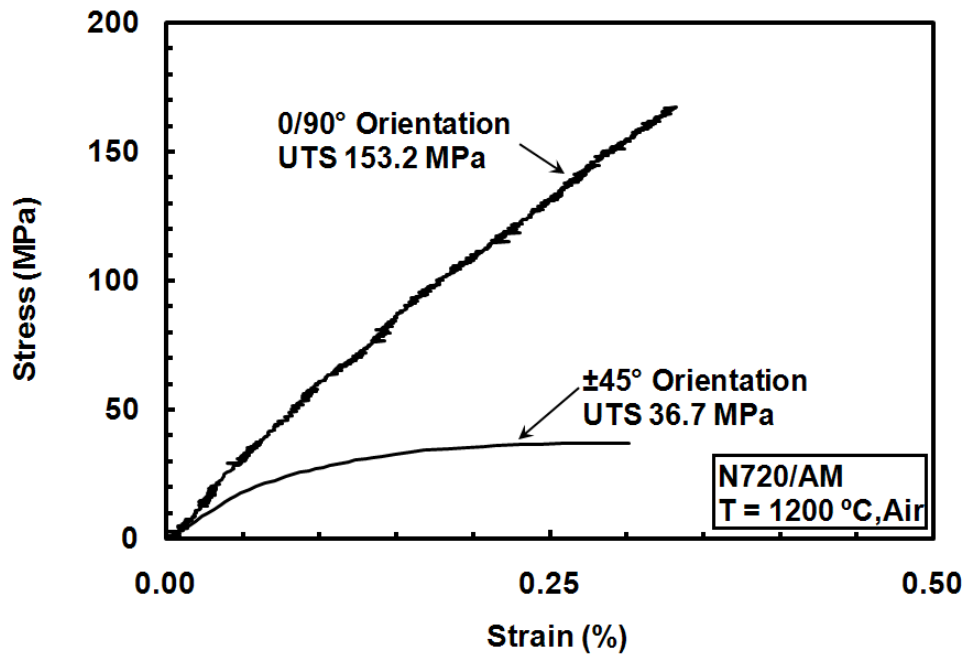
Figure 13. Tensile stress-strain curves for N720/AM ceramic composite at 1200°C in laboratory air. Data for 0°/90° fiber orientation from Genelin [21].

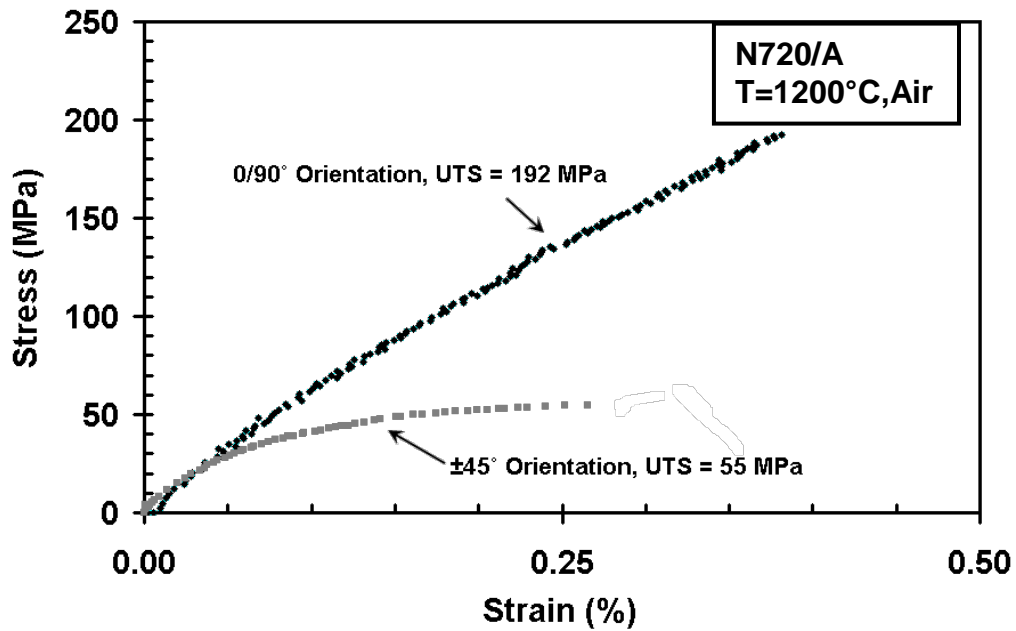
Figure 14. Tensile stress-strain curves for N720/A ceramic composite at 1200°C in laboratory air. Data for N720/A from Siegert [16], Harlan [20].

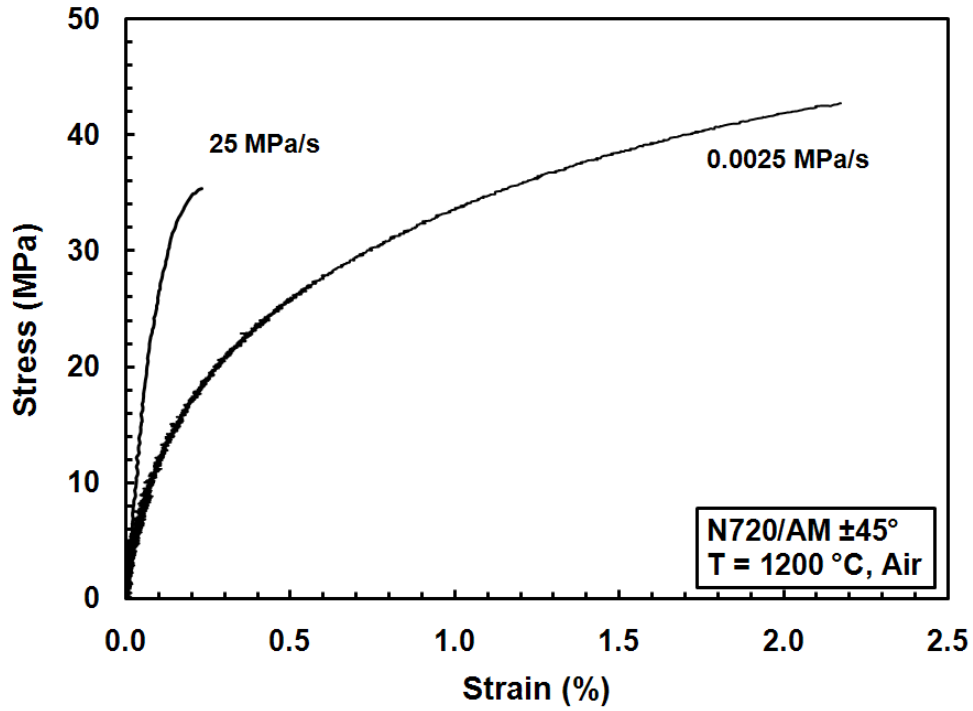
Figure 15. Tensile stress-strain curves for N720/AM composite with $\pm 45^\circ$ fiber orientation at 1200°C in laboratory air. Dependence of stress-strain behavior and tensile properties on stress rate is evident.

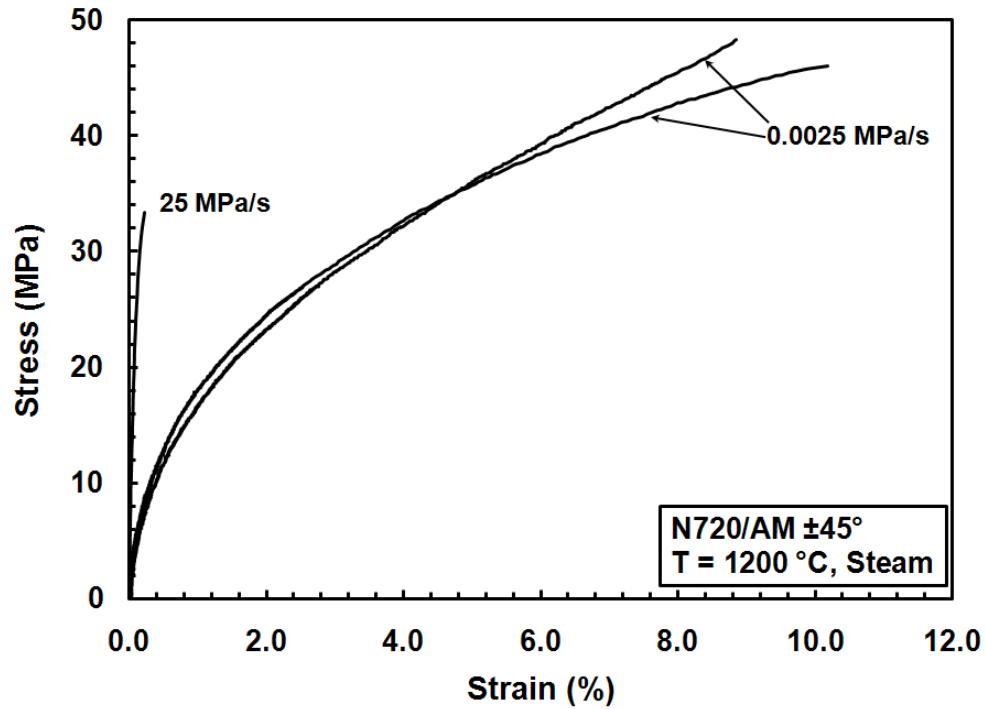
Figure 16. Tensile stress-strain curves for N720/AM composite with $\pm 45^\circ$ fiber orientation at 1200°C in steam. Dependence of stress-strain behavior and tensile properties on stress rate is evident.

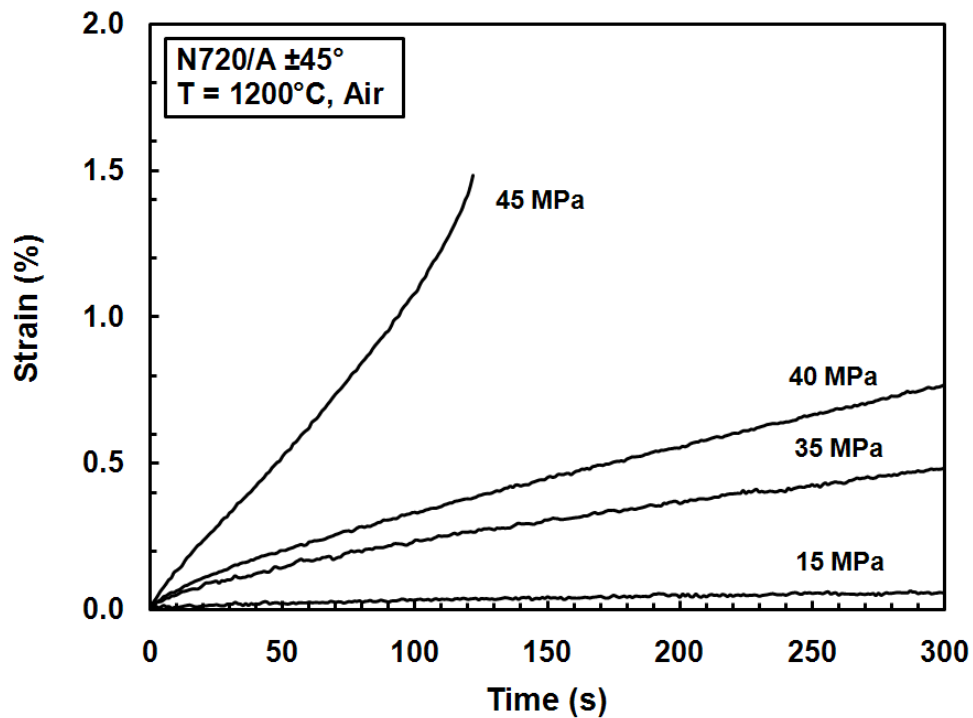
Figure 17. Creep vs. time curves for N720/A composite with $\pm 45^\circ$ fiber orientation obtained at 1200°C in laboratory air. Data for N720/A from Siegert [16], Ruggles-Wrenn et al [17].

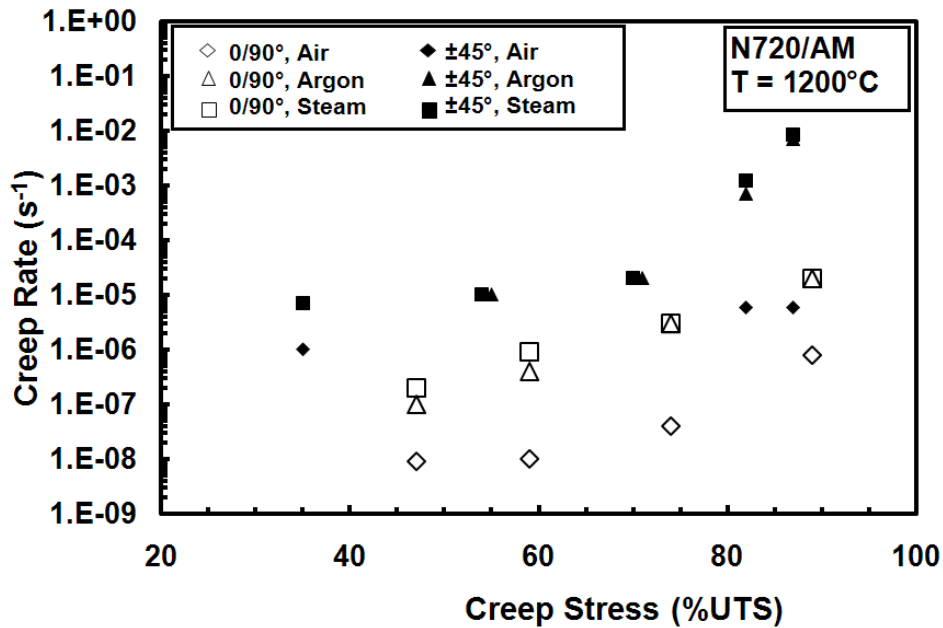
Figure 37. Creep rate vs. creep-stress for N720/AM with 0°/90° and ±45° fiber orientations at 1200°C in laboratory air, steam and argon. Data for N720/AM with 0°/90° fiber orientation from Genelin [21].

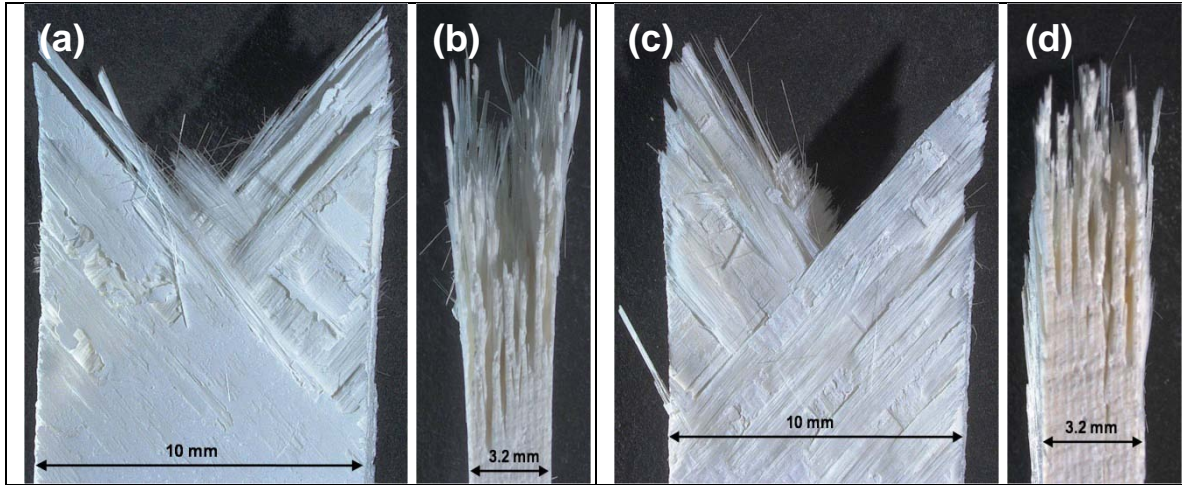
Figure 38. Fracture surfaces of the N720/AM specimens with $\pm 45^\circ$ fiber orientation subjected to tensile test to failure following 100 h at 1200°C in laboratory air at: (a)-(b) 13 MPa and (c)-(d) 32 MPa

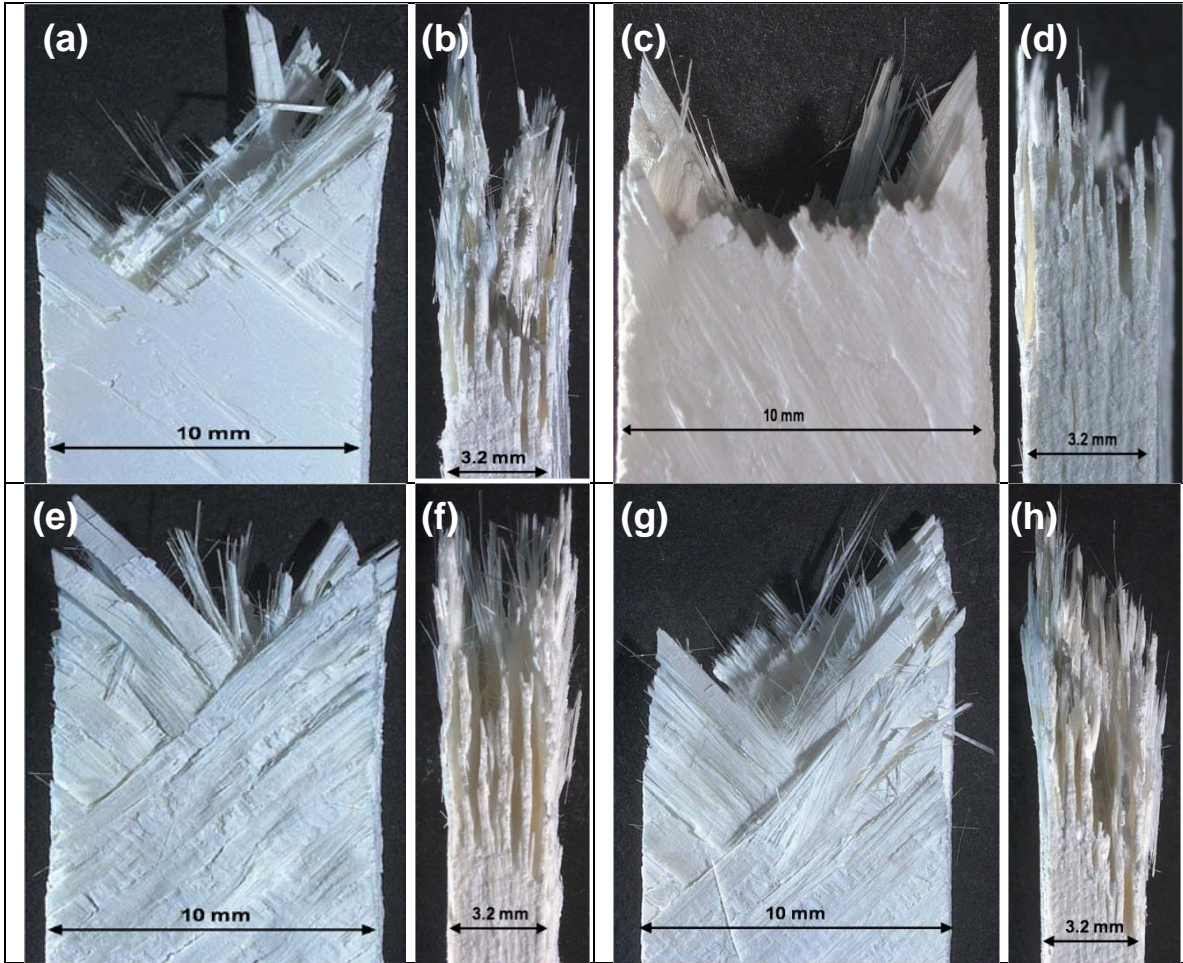
Figure 39. Fracture surfaces of the N720/AM specimens with $\pm 45^\circ$ fiber orientation obtained in creep tests conducted at 1200°C in steam at: (a)-(b) 13 MPa, $t_f = >100$ h; (c)-(d) 20 MPa, $t_f = >100$ h; (e)-(f) 30 MPa, $t_f = 1.08$ h and (g)-(h) 32 MPa, $t_f = 0.02$ h

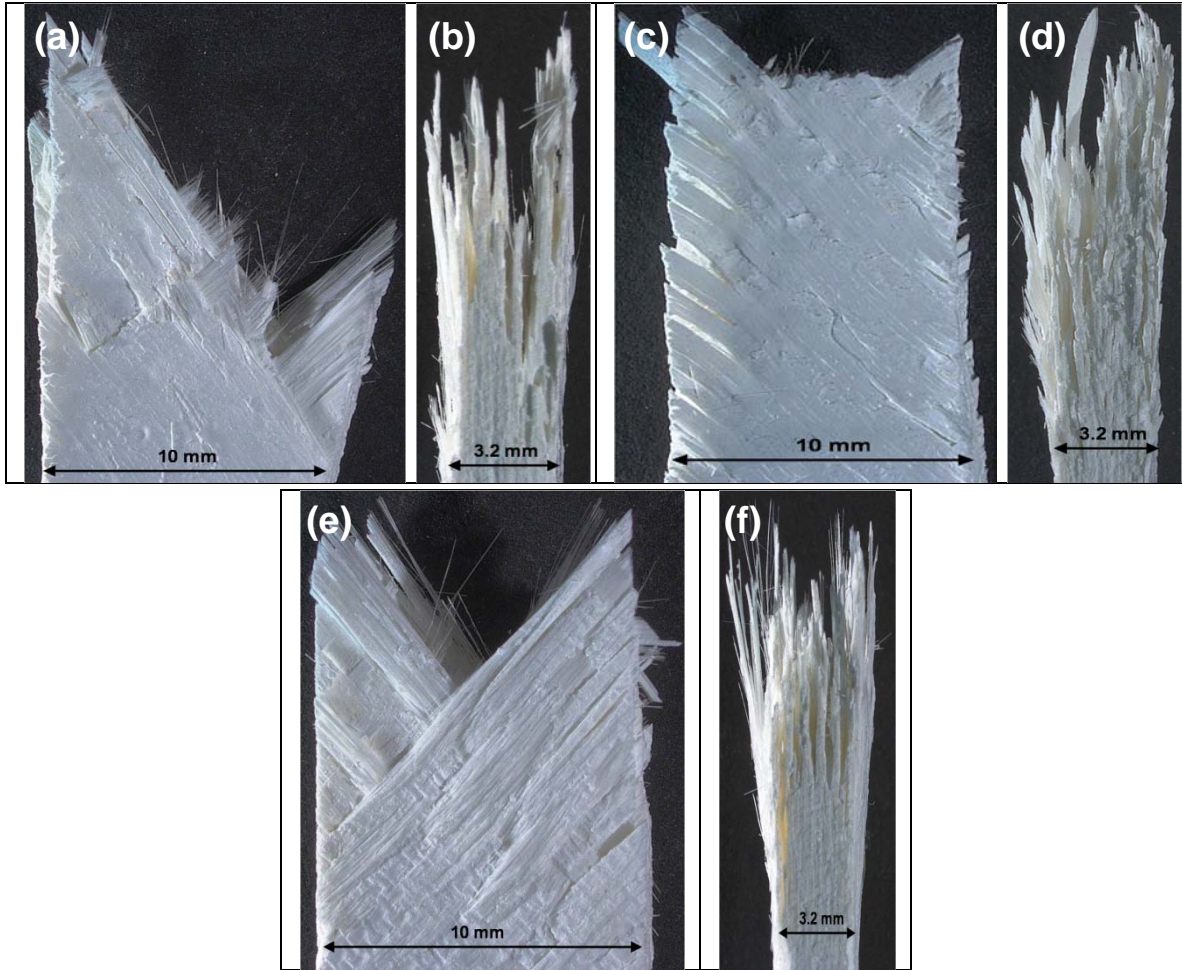
Figure 40. Fracture surfaces of the N720/AM specimens with $\pm 45^\circ$ fiber orientation obtained in creep tests conducted at 1200°C in argon at: (a)-(b) 20 MPa, $t_f = >100$ h; (c)-(d) 26 MPa, $t_f = 76$ h and (e)-(f) 32 MPa, $t_f = 0.08$ h

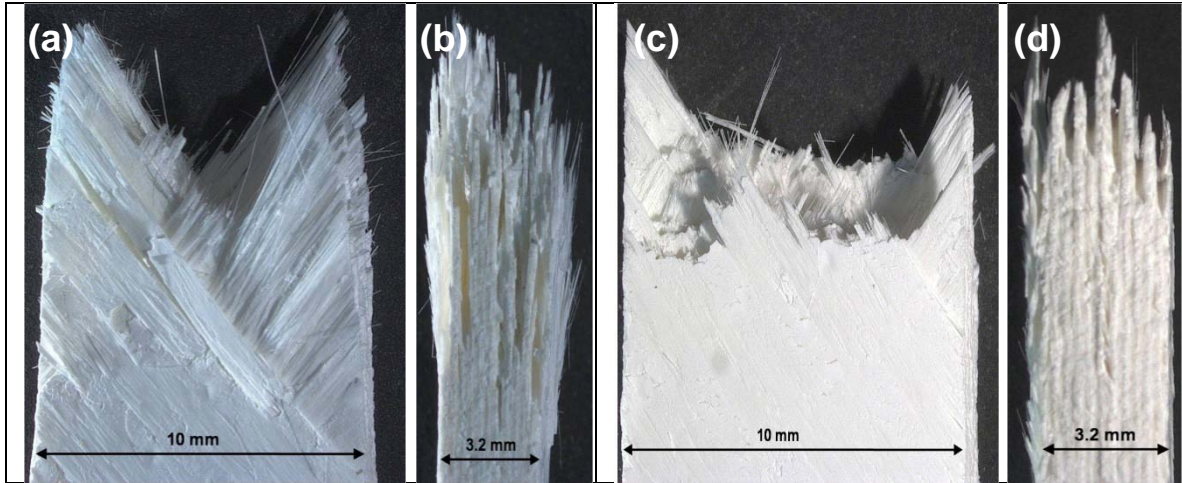
Figure 41. Fracture surfaces of the N720/AM specimens with $\pm 45^\circ$ fiber orientation obtained from load controlled tensile tests at 1200°C at 0.0025 MPa/s in: (a)-(b) laboratory air, $t_f = 4.76\text{ h}$; (c)-(d) steam, $t_f = 5.46\text{ h}$

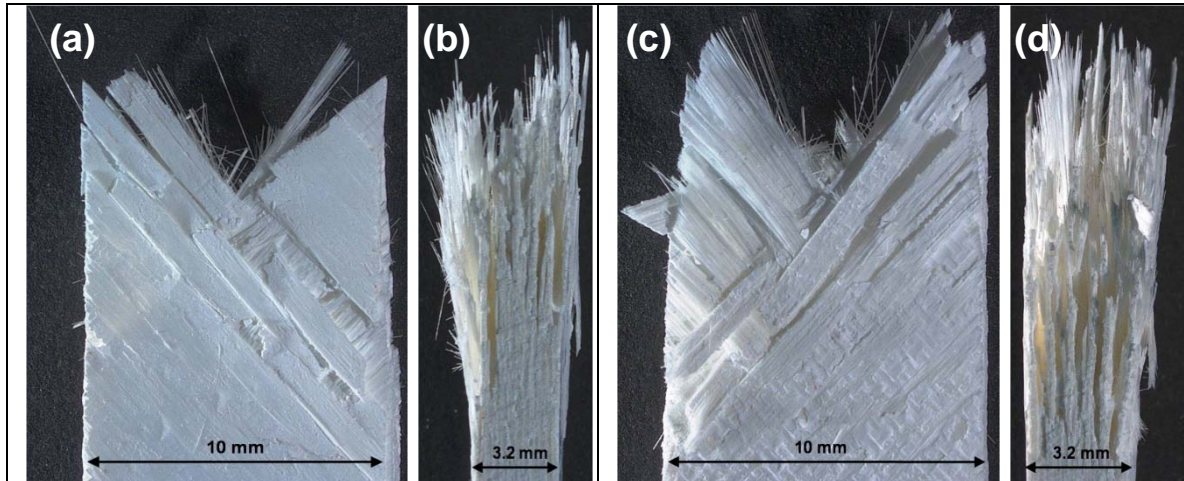
Figure 42. Fracture surfaces of the N720/AM specimens with $\pm 45^\circ$ fiber orientation obtained from load controlled tensile tests at 1200°C at 25 MPa/s in: (a)-(b) laboratory air, $t_f = 0.0004\text{ h}$; (c)-(d) steam, $t_f = 0.00038\text{ h}$

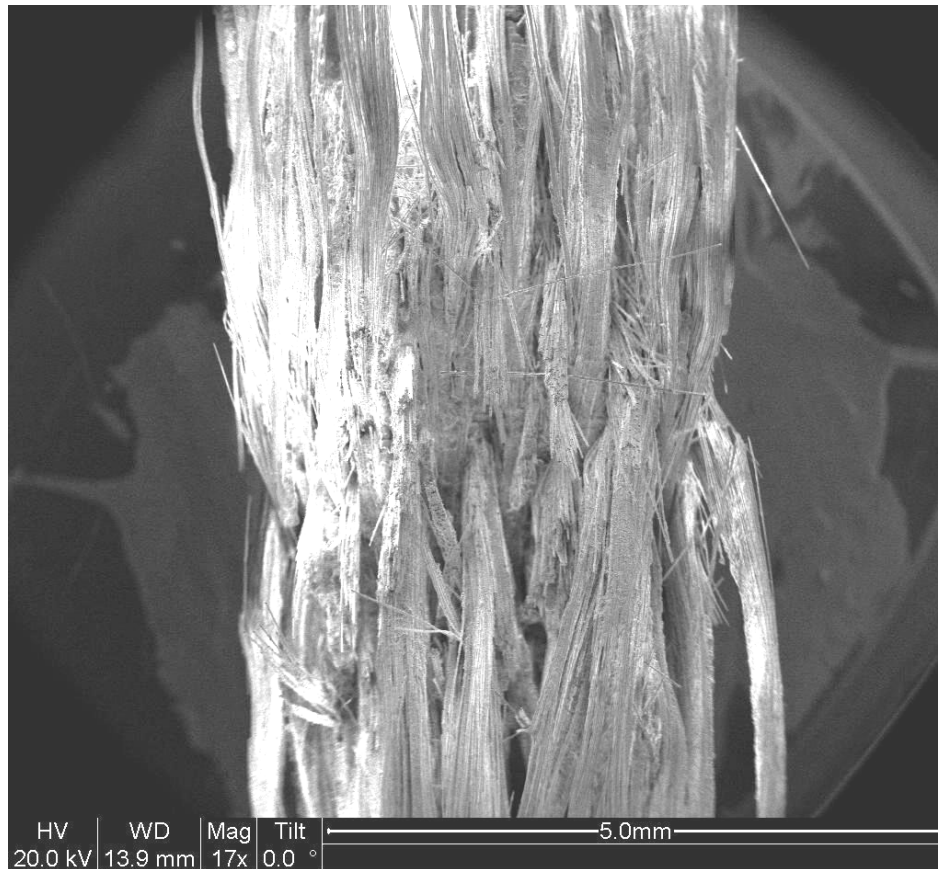
Figure 44. SEM micrograph of the fracture surface of the N720/AM with $\pm 45^\circ$ fiber orientation subjected to tensile test to failure at 1200°C in laboratory air

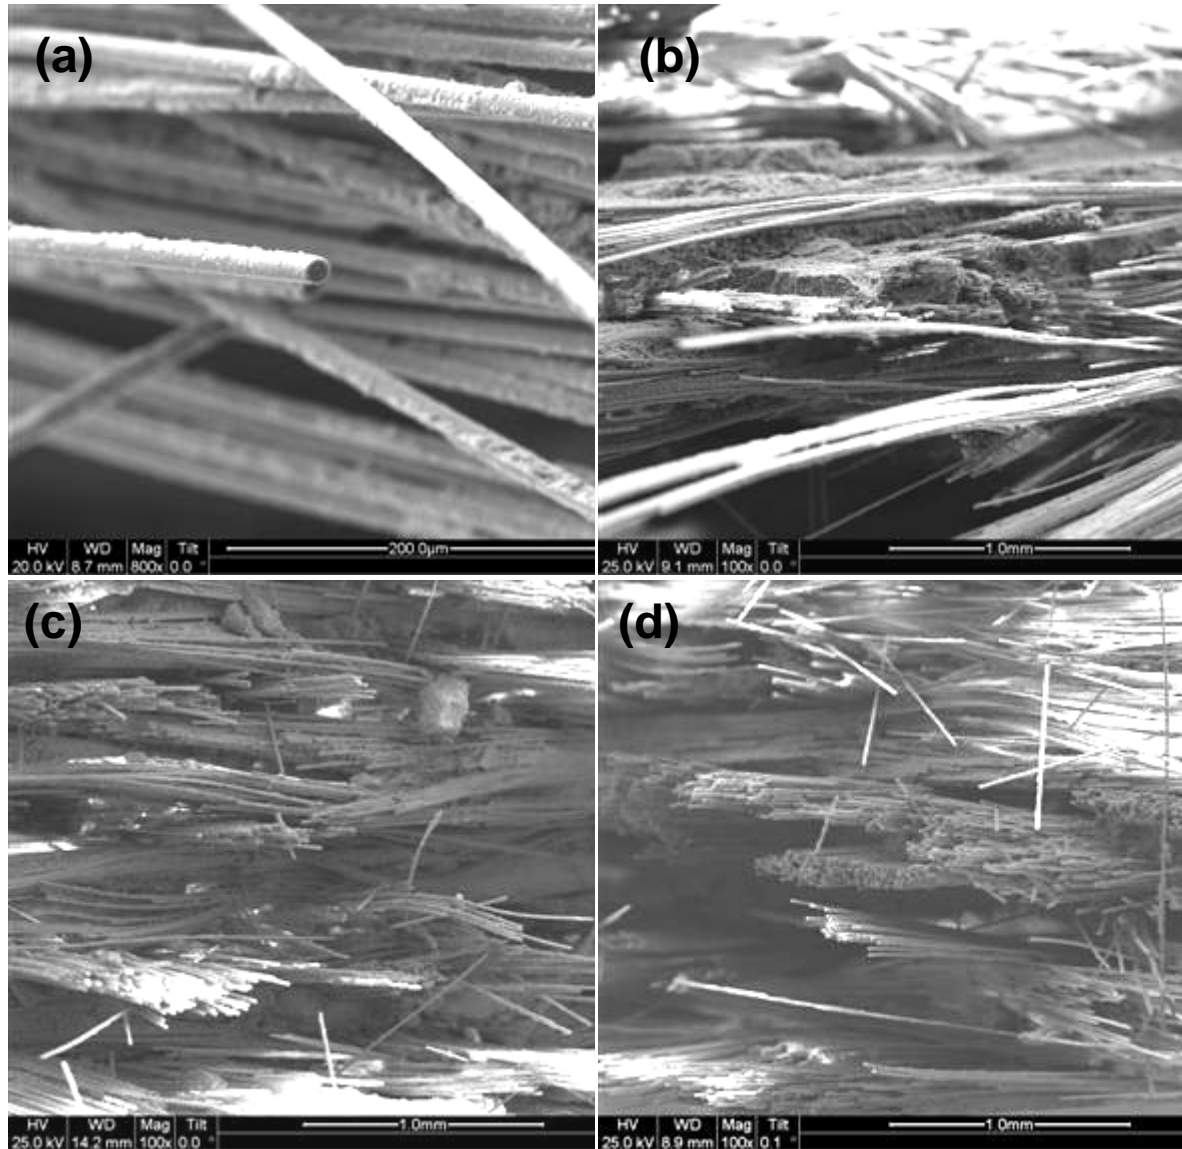
Figure 45. SEM micrographs of fracture surfaces of N720/AM with $\pm 45^\circ$ fiber orientation produced in creep tests conducted in laboratory air at 1200°C at: (a) - (b) 13 MPa, (c) 30 MPa and (d) 32 MPa

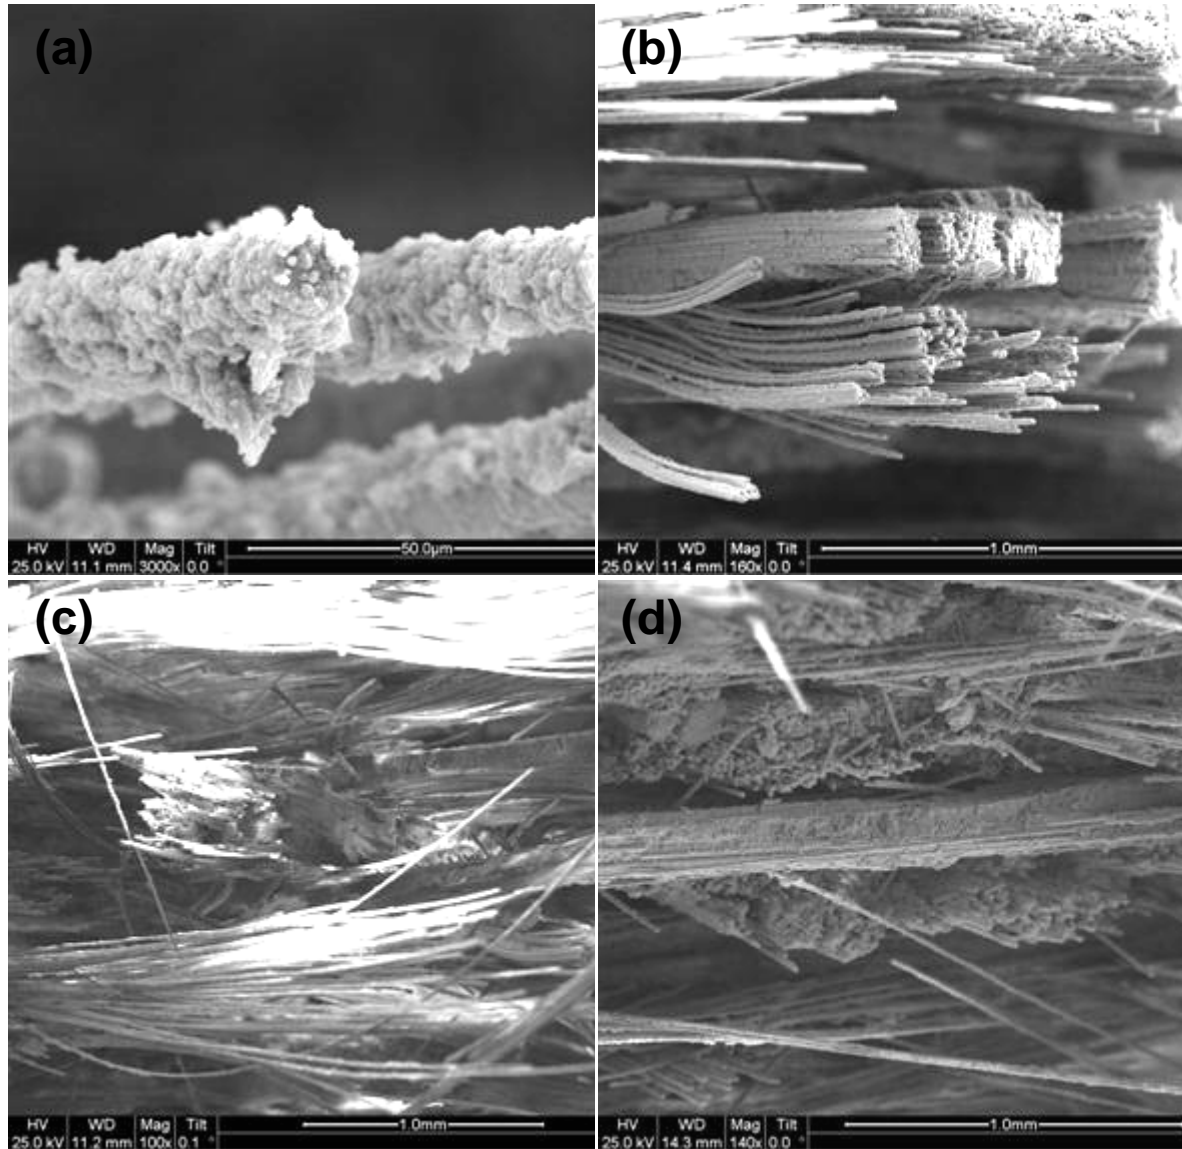
Figure 46. SEM micrographs of fracture surfaces of N720/AM with $\pm 45^\circ$ fiber orientation produced in creep tests conducted in steam at 1200°C at: (a) - (b) 13 MPa, (c) 30 MPa and (d) 32 MPa

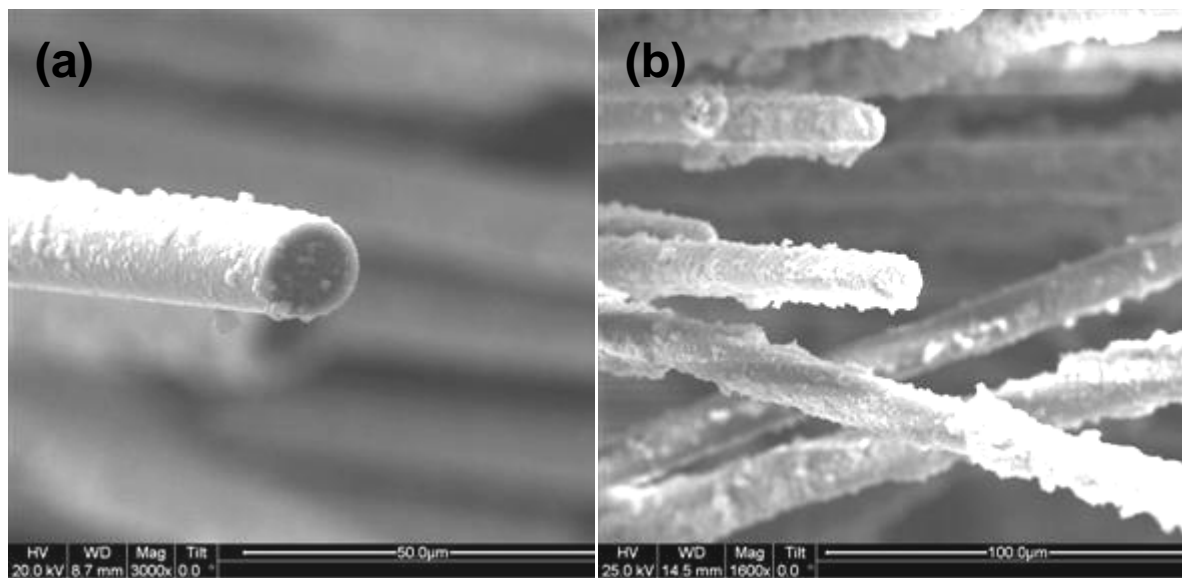
Figure 47. SEM micrographs of N720/AM fibers subjected to creep tests at 1200°C conducted in: (a) laboratory air at 13 MPa and (b) steam at 32 MPa

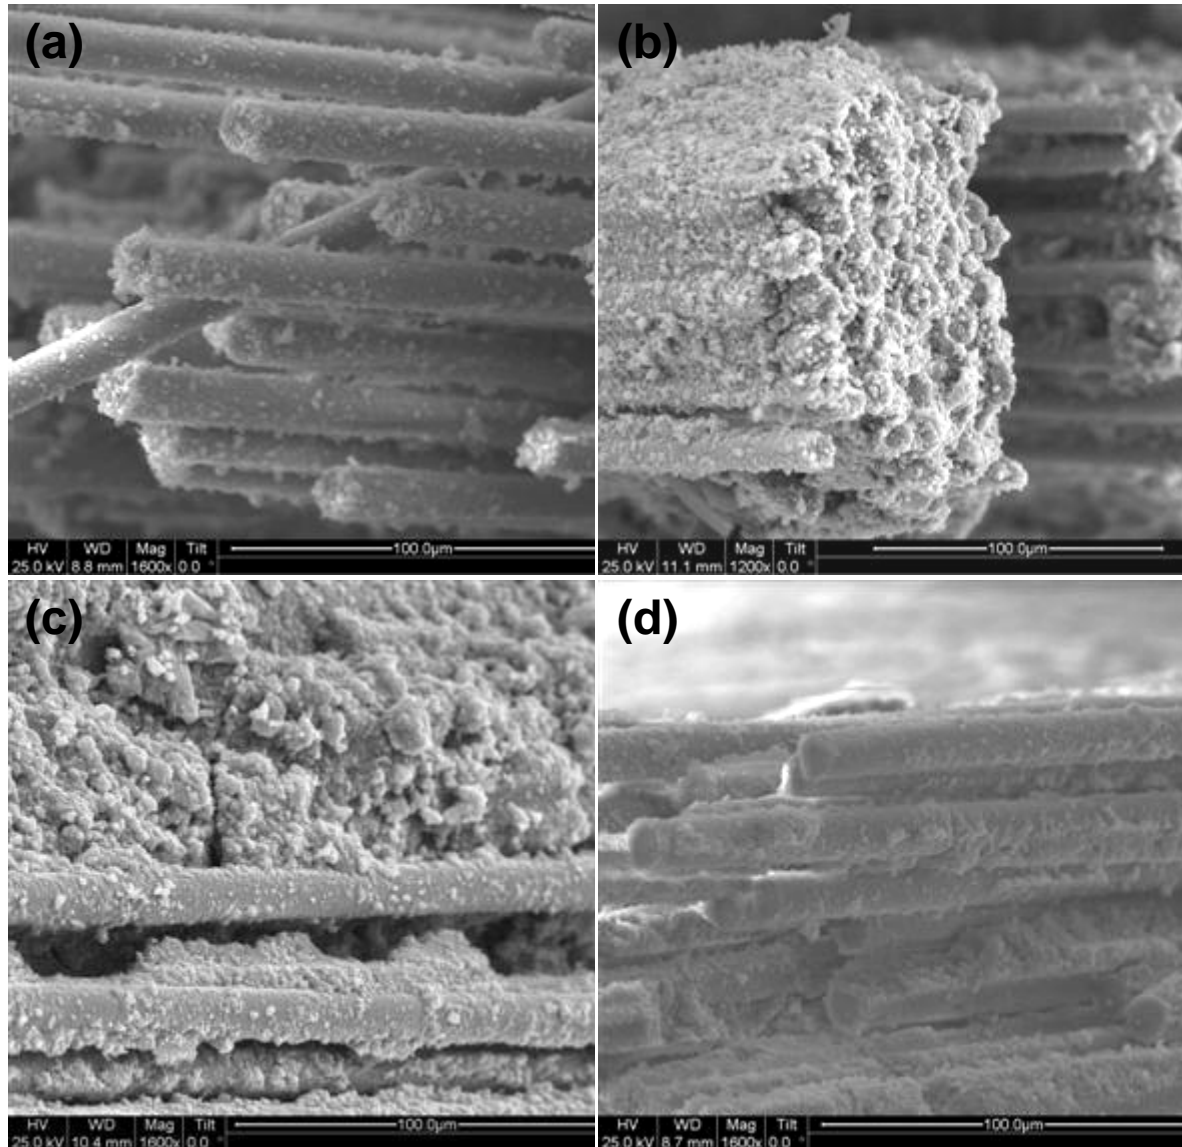
Figure 48. SEM micrographs of N720/AM fiber bundles subjected to creep tests at 1200°C conducted in: (a) laboratory air at 32 MPa , (b)-(c) steam at 13 MPa and (d) steam at 30 MPa

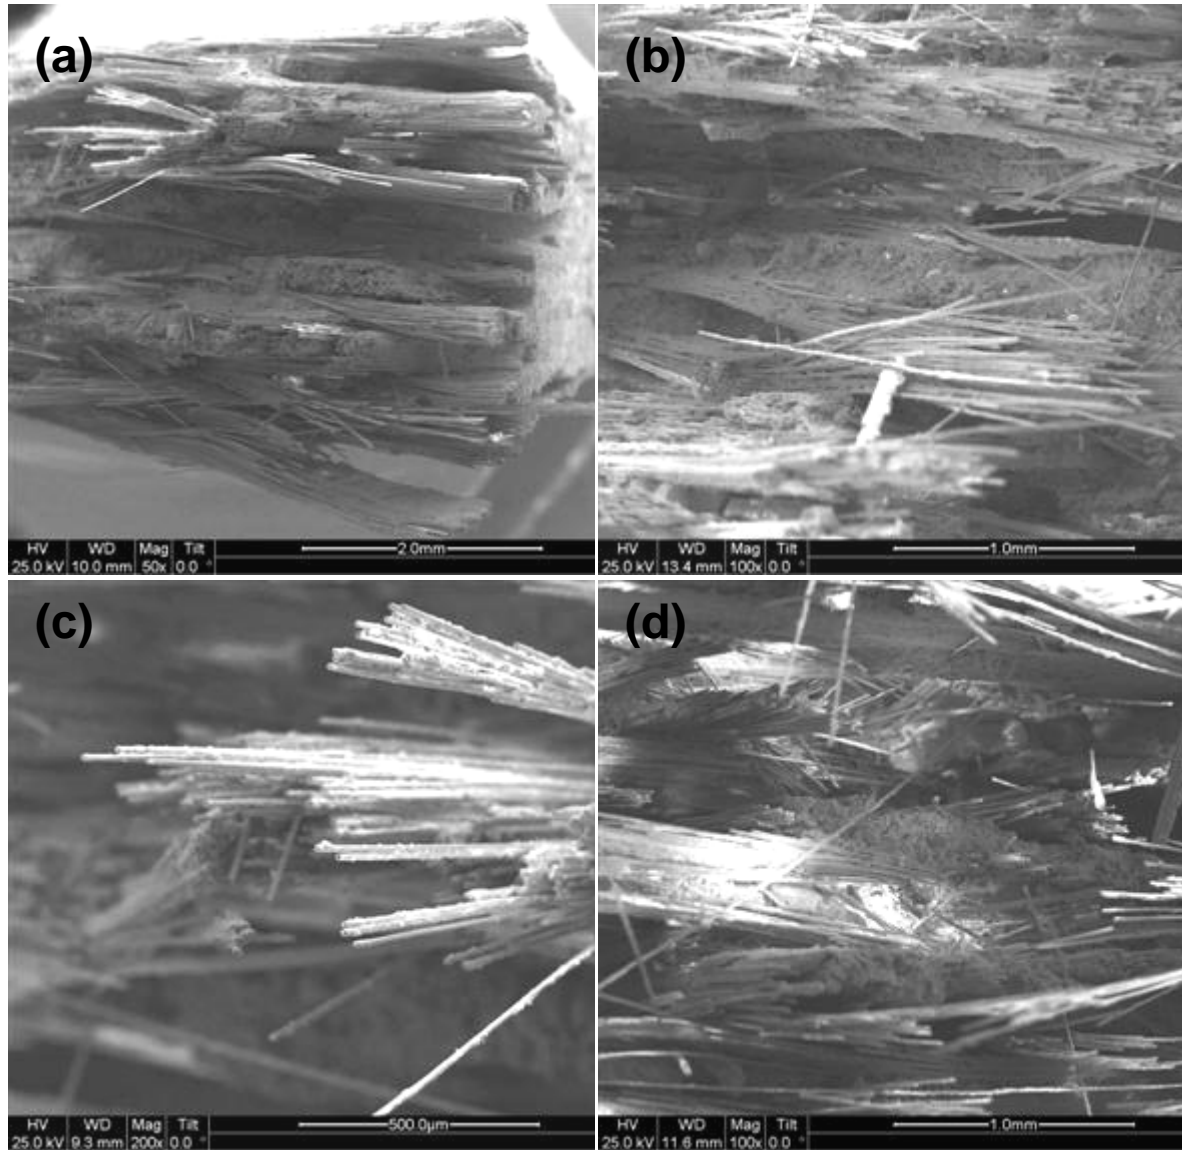
Figure 49. SEM micrographs of fracture surfaces of N720/AM with $\pm 45^\circ$ fiber orientation produced in creep tests conducted in argon at 1200°C at: (a)-(b)-(c) 20MPa and (d) 32 MPa

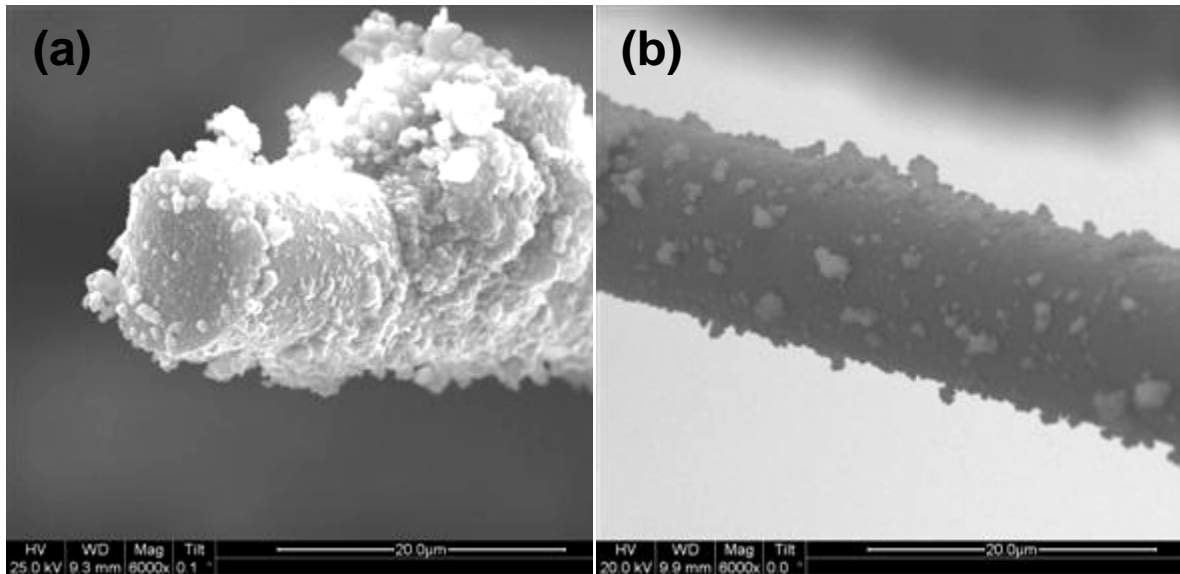
Figure 50. SEM micrographs of N720/AM fibers subjected to creep tests at 1200°C conducted in argon at: (a) 20 MPa (t_f >100 h) and (b) 30 MPa (t_f = 3.42 h)

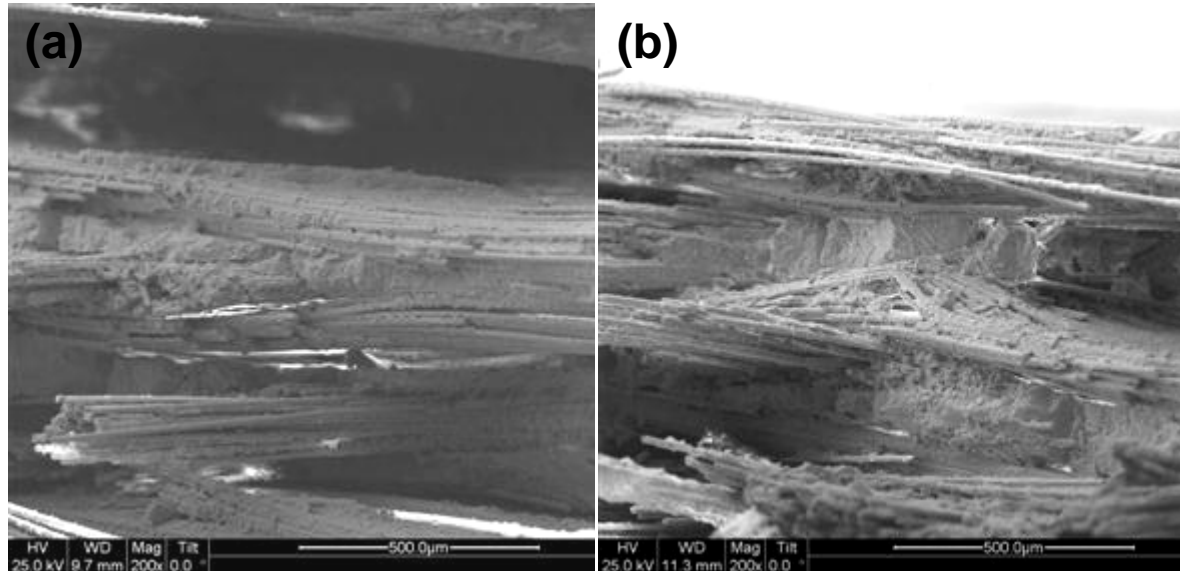
Figure 52. SEM micrographs of fracture surfaces of N720/AM with $\pm 45^\circ$ fiber orientation produced in creep tests at 1200°C conducted at 20 MPa in argon

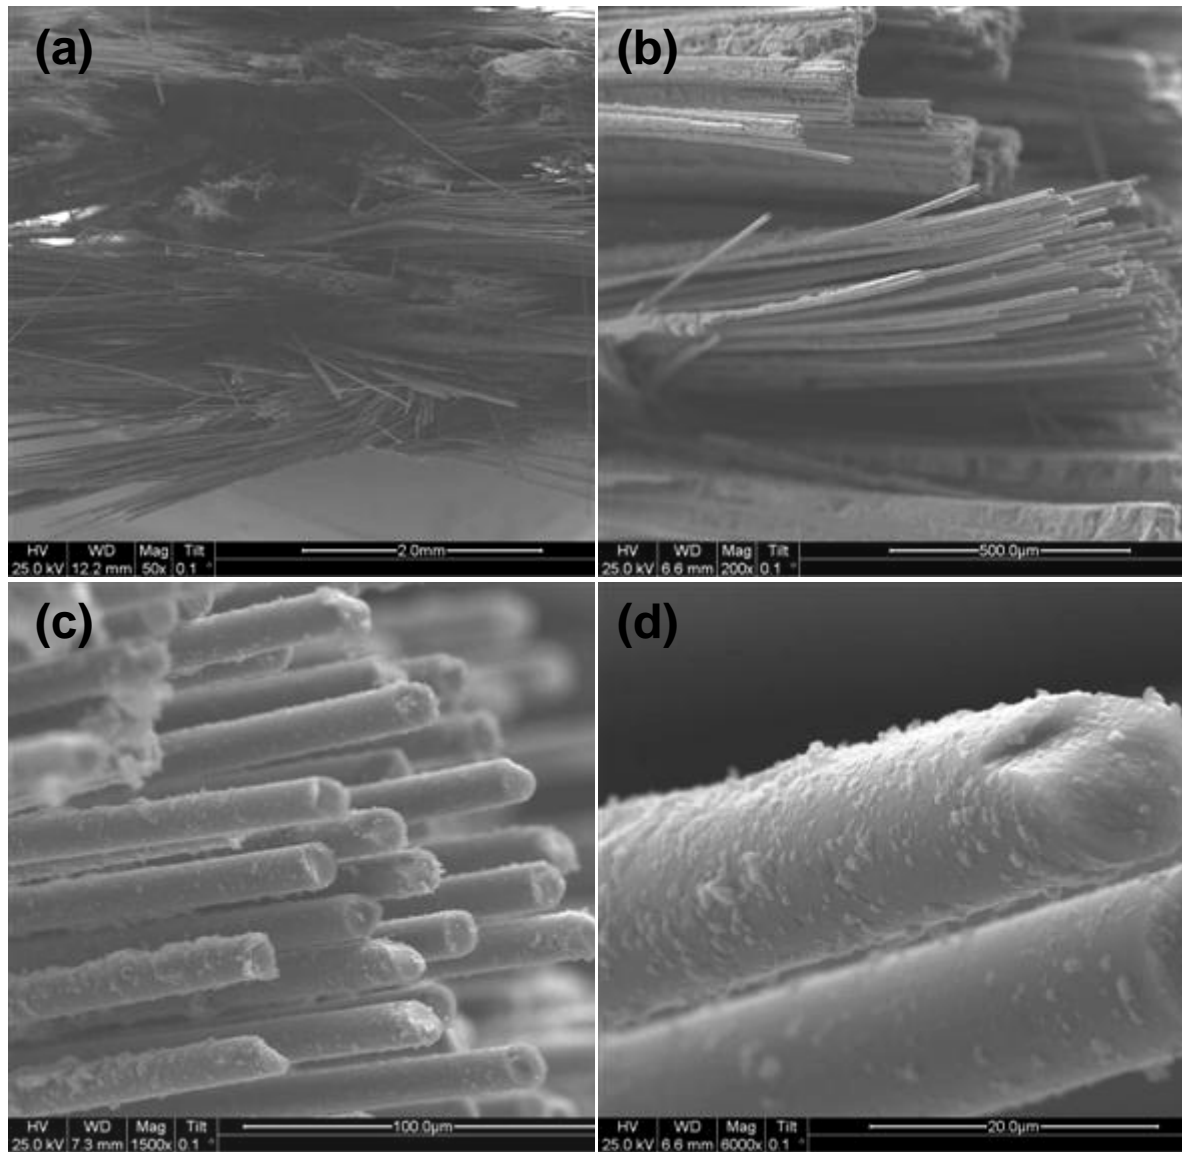
Figure 53. SEM micrograph of the fracture surface of the N720/AM specimen with $\pm 45^\circ$ fiber orientation subjected to tensile test to failure with a constant stress rate of 0.0025 MPa/s at 1200°C in laboratory air
